REPAIR, EVALUATION, MAINTENANCE, AND REHABILITATION RESEARCH PROGRAM

TECHNICAL REPORT REMR-CS-2

THE CONDITION OF CORPS OF ENGINEERS CIVIL WORKS CONCRETE STRUCTURES

April 1985 Final Report

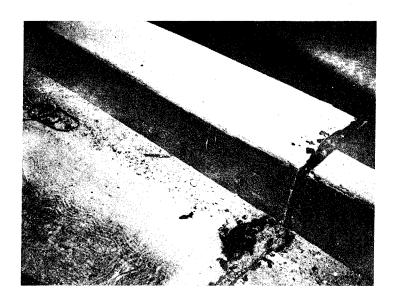
Figure C1. Construction faults (sheet 1 of 2)

a. Light (inadequate concrete cover over reinforcing steel)

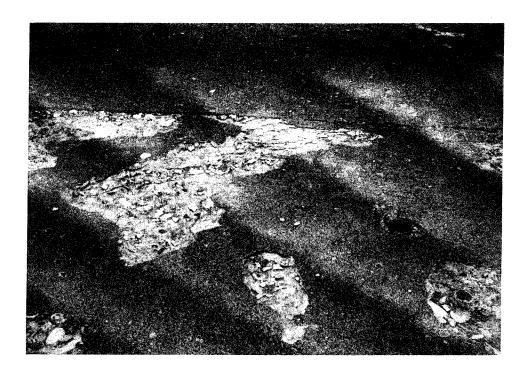
Figure C3. Concrete disintegration (sheet 1 of 2)

a. Light

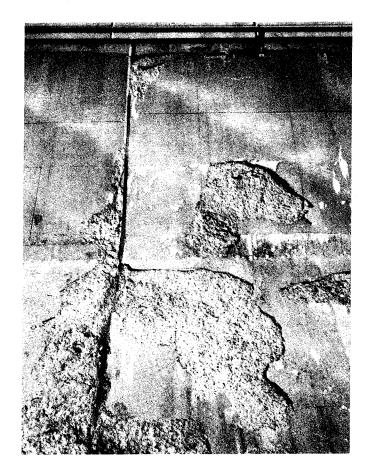
Figure C3. Concrete disintegration (sheet 2 of 2)

c. Severe

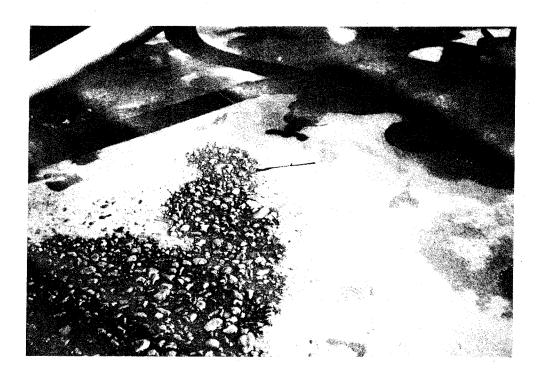
Figure C5. Concrete erosion (sheet 1 of 2)

a. Light

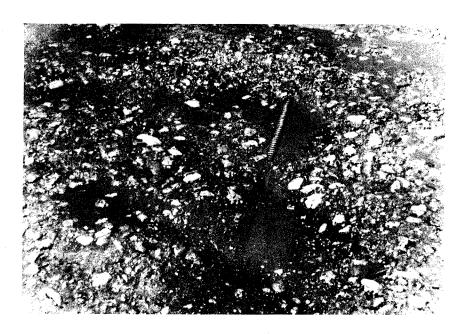
b. Moderate
